Issue Evaluation

Issue:	IE07-080
Date Submitted:	5-Sep-07
Subject:	Non-Deployment of Airbags
Prompted by:	Consumer Complaints/Fatal Crash Reports
Supported by:	Consumer Complaints / EWR Data
Investigator:	Donovan Green / Daniel Hillman
Subject Vehicles:	2003, 2004, 2005 Saturn Ion 2005, 2006 Chevy Cobalt
Population:	Saturn Ion: 288,463 Chevy Cobalt: 389,203
Problem Description:	Driver and passenger side frontal airbags fail to deploy during crash events where injury severity, CDR data, structural deformation and deaths suggest the airbags should have deployed.
Complaints	29
Crashes	29
Injuries	11
Deaths	4
Other (Describe "Other")	14 (Field Reports)
Additional Comments

ISSUE EVALUATION MEMORANDUM

The frontal airbags in the 2003/2004 Saturn Ion and 2005/2006 Chevy Cobalt may not deploy in certain crash events where supporting evidence shows that the airbags should have deployed. Failure of an airbag to deploy can result in reduced protection for vehicle occupants, and may result in injury or death.

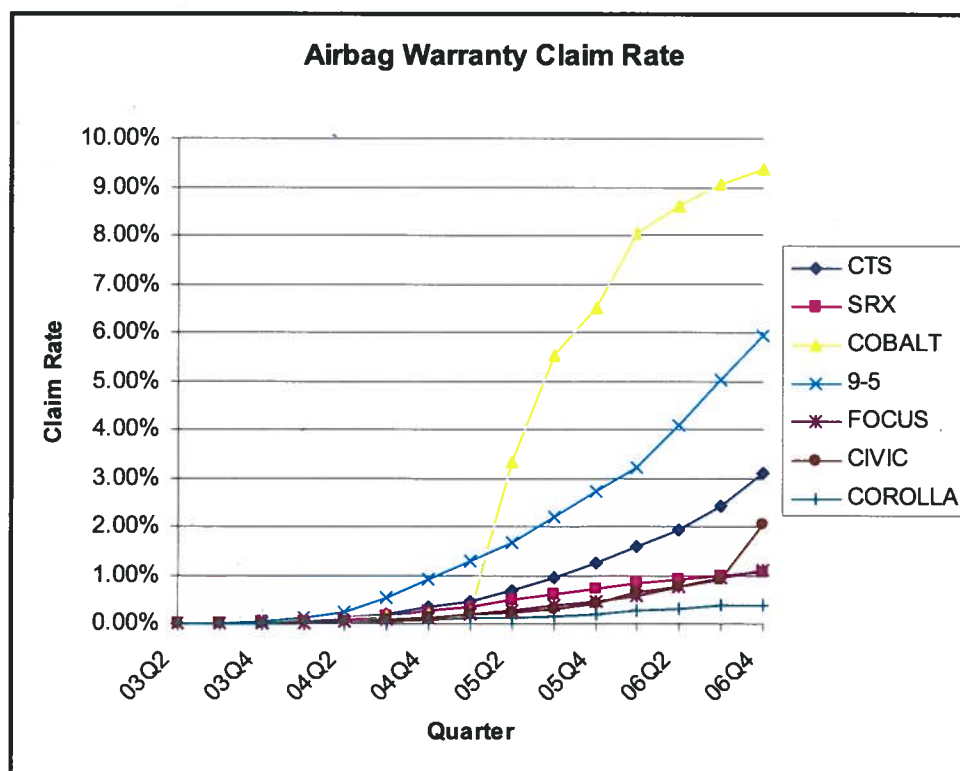
Figure 4.

Supporting data has also been submitted by the Early Warning Division that shows similar reports and trends. Of particular interest, ranking studies performed by Bill Duckwitz and Scott Yon for warranty claims on airbags, placed the 2004-2006 Cobalt at the top of the list for both total claims (54, 642) and for claims per 1,000 vehicles (93.4). The 2004-2006 Cobalt also ranked first for total property damage claims, and second for property damage claims per 1,000 vehicles.

Figure 4 below shows a comparison of warranty claim rates for airbags for the Cobalt and several other vehicles from the second quarter of 2003 through the last quarter of 2006.

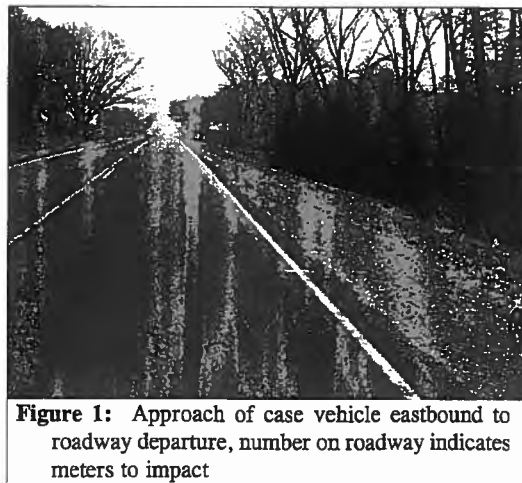
Pre-Crash: The case vehicle was traveling east in the eastbound lane (Figure 1). The case vehicle's driver was intending to continue eastbound. For an unknown reason, the case vehicle departed the south side of the roadway. The crash occurred on the south side of the roadway on the edge of a wooded area.

Figure 1: Approach of case vehicle eastbound to roadway departure, number on roadway indicates meters to impact

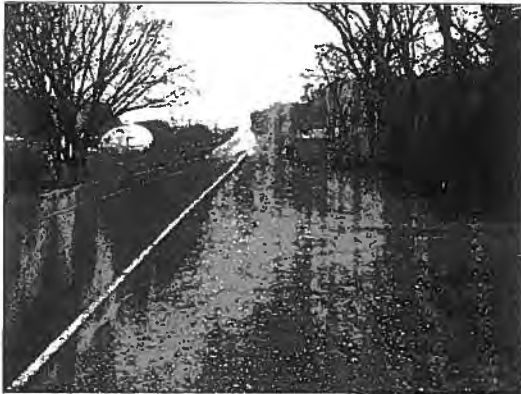
Crash: After the case vehicle departed the south side of the roadway, it crossed the south shoulder and the right side tires entered the grass. The case vehicle then encountered the edge of a driveway (Figure 2 below), vaulted and was airborne for approximately 18 meters (59 feet).

Figure 2: Path of case vehicle to vault at driveway

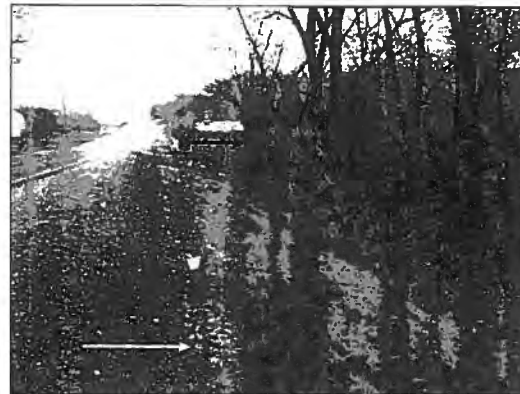
The case vehicle touched down in the grass (Figure 3) and traveled an additional approximate 24 meters (79 feet) where the center front of the case vehicle impacted and ran over a telephone utility box (event 1). The case vehicle traveled an additional approximate 15 meters (49 feet) and the front right impacted a clump of large trees (event 2). The center right of the case vehicle initially engaged the leading tree in the clump and then the front right engaged a tree immediately behind and to the right of it (Figures 4 and 5). The first tree was displaced in the ground and broken off at the root. It appeared that a branch from this tree also broke off and impacted the top of the case vehicle and broke out the backlite (event 3). The case vehicle's driver and front right air bags did not deploy as a result of the impact with the clump of trees, possibly due to the yielding nature of the impact with the first tree (See the Crash Data Recording discussion below).

Figure 3: Vehicle touchdown location (yellow arrow) from vault and approach to telephone utility box impact (red arrow) and impact with clump of trees (blue arrow)

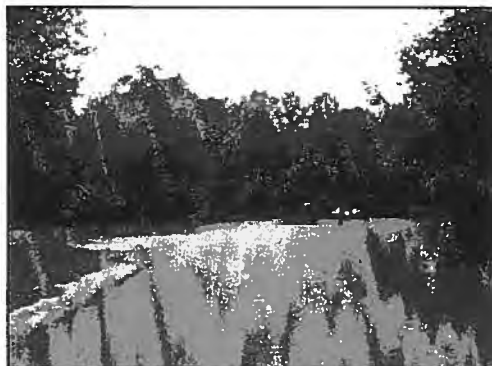
The 16-year old female driver was attending a house party at a residence located at the mouth of the cul-de-sac. She was under the influence of alcohol with a toxicology reported BAC of .17. The driver was not restrained by the manual 3-point lap and shoulder belt safety system. The lack of belt usage was determined from the vehicle inspection and EDR data. She left the party alone during the nighttime hours and attempted to exit the rural subdivision. For an unknown reason, the driver returned toward the cul-de-sac, traveling in a southerly direction on the left side of the two lane non-delineated roadway (**Figure 2**). The EDR recorded pre-crash data for a five-second interval prior to the Non-Deployment record. These data points indicated that the driver was accelerating at 100 percent throttle with a constant increase in engine RPMs and vehicle speed throughout this timeframe. The Cobalt's speed increased from 85 km/h (53 mph) at the five-second interval to 111 km/h (69 mph) at one-second of Algorithm Enable (AE). There was no evidence of braking at the crash site, and the EDR did not record brake application during the five-second pre-crash intervals.

Figure 2. Pre-crash travel direction and overall view of the crash site.

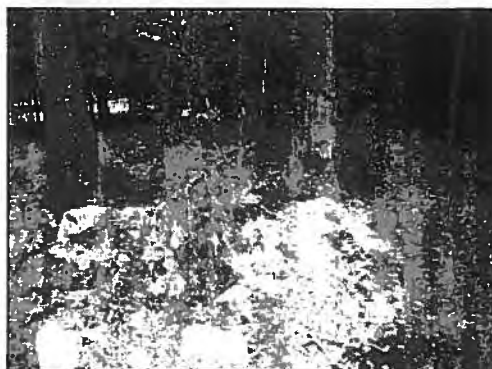
As the Cobalt traversed the mouth of the driveway, the undercarriage overrode the landscaping, which consisted of flush mounted rocks within the dirt and mulch. The front left area of the vehicle narrowly missed a large rock that was positioned vertically within the landscaped area. The Cobalt continued forward in a tracking mode and impacted a 13 cm (5") diameter pine tree with the front left area of the vehicle. The resultant direction of force for this impact event was 12 o'clock. The impact uprooted the tree, but did not fracture the 13 cm (5") trunk. The Cobalt carried the tree forward as this impact produced a minimal velocity change to the vehicle. (The delta V could not be calculated due to the masking of damage by the subsequent impact). **Figure 3** is an overall view of the crash site.

Figure 3. Overall view of the crash site.

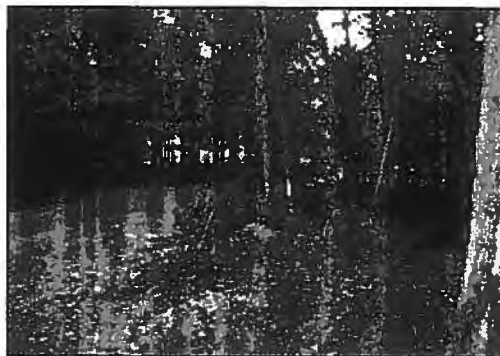
Figure 5. Area of impact with the four small diameter trees and final rest.

As the Cobalt rotated CW, the left side area impacted four small diameter trees that were located 2.8-4.6 m (9-15') south of the 51 cm (20") diameter tree (Figure 5). The lateral impact deflected the trees, which resulted in a ramping effect as the undercarriage of the Cobalt rode up the trees. This ramping effect resulted in an overturn (flip-over) of the Cobalt as it rolled one-quarter turn onto its right side. The Cobalt continued to rotate approximately 40 degrees about its longitudinal axis prior to coming to rest on its side.

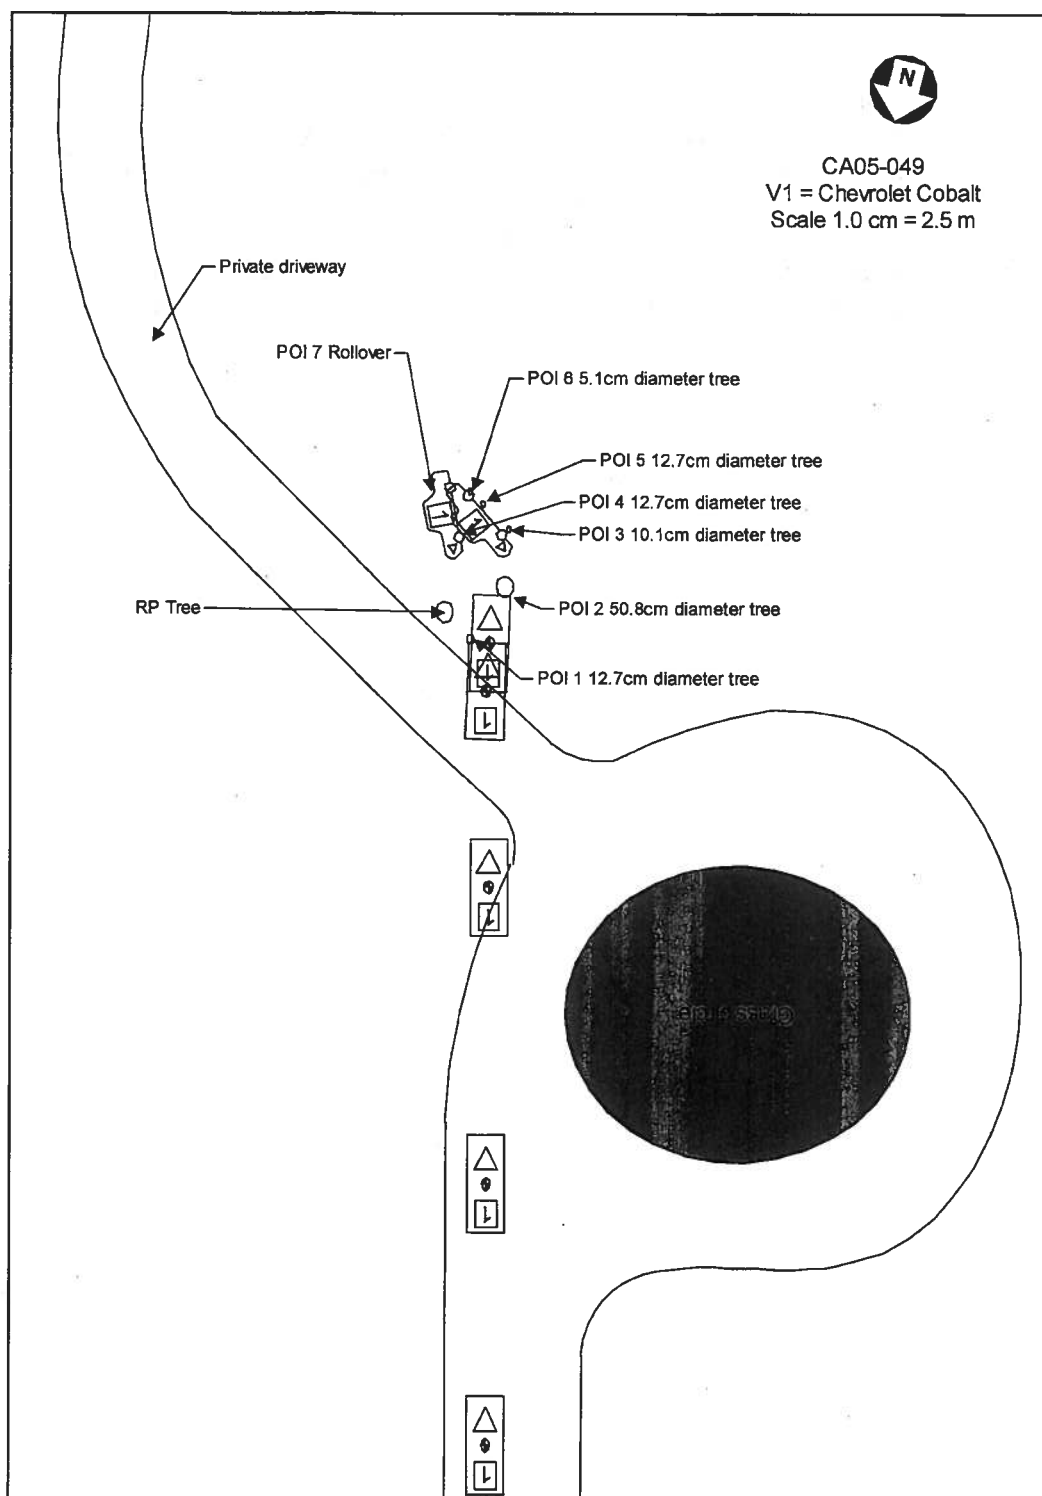
Figure 11: Scene Schematic

The crash occurred in a remote, rural residential area at the end of a cul-de-sac roadway during dark, nighttime hours. At the time of the crash, the weather conditions were police reported as overcast with wet environmental surfaces from a previous rainfall. A two-lane asphalt surfaced roadway terminated at a 29.8 m (98') diameter cul-de-sac, which formed a circular loop to the right of the approach roadway. The roadway was 6.4 m (21') in width and was bordered by grass/vegetation with no stabilized shoulders. A 17 m (55.8') diameter grass circle was centered within the cul-de-sac. The posted speed limit for the area was 40 km/h (25 mph). There were no lane lines or edge line markings on the road. A residential driveway intersected the cul-de-sac at the top, left aspect of the circle, with respect to vehicle travel. Numerous trees and a rock-landscaped area bordered the edges of the driveway and the cul-de-sac. At the crash site, the initial impact involved a 13 cm (5") diameter (soft wood) tree, a 51 cm (20") diameter oak tree, and four small trees that ranged in diameters of 5-13 cm (2-5"). The scene schematic is included as **Figure 11**.
